Technical Note N-1267

ANALYSIS OF HYDROPHONE SUPPORT STRUCTURE
AFTER 52-1/2 MONTHS EXPOSURE AT A DEPTH
OF 5270 FEET IN THE BARKING SANDS TEST
RANGE, KAUAI, HAWAII

March 1973

NAVAL CIVIL ENGINEERING LABORATORY
Port Hueneme, California 93043

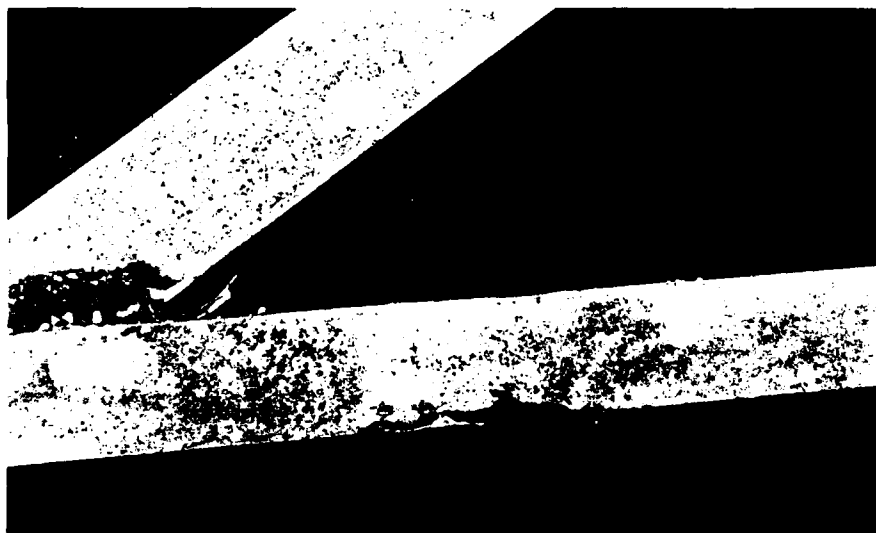
Pitting attack on boldly exposed areas of some components of the structure resulted in structurally severe damage. The most severely pitted components were the base ring braces and the yoke. Pitting of the base ring braces, as shown in Figure 7, initiated at the edges of the members and had progressed up to 1" into them at several areas. Metallographic inspection of the base ring brace channel and bar did not show any continuous precipitate at the grain boundaries. The corrosion was transgranular. The clips at the ends of the braces where the base ring was attached were also severely corroded as shown in Figure 6. This attack also initiated at the edges of the clips. Metallographic inspection of sections of these clips revealed a continuous network of Mg_2Al_3 precipitated at the grain boundaries and the usual attendant intergranular attack. The severity of the attack on the base ring braces can be partially attributed to the exposure of the braces to the bottom sediments.

Figure 7. Pitting on base ring brace.

1. Complete isolation of dissimilar metals must be achieved. Inspection of assembled structures to assure isolation is recommended.
2. Elimination of contact between the bottom sediments and any aluminum structural members is recommended.
3. Elimination, by design, of any unnecessary crevices is recommended.
4. The continued use of 5086 aluminum alloy as the most corrosive resistant aluminum alloy is recommended. However, 5086 alloy in the as extruded (H-111) condition is preferred to other conditions where intergranular precipitation and its associated accelerated attack is possible.

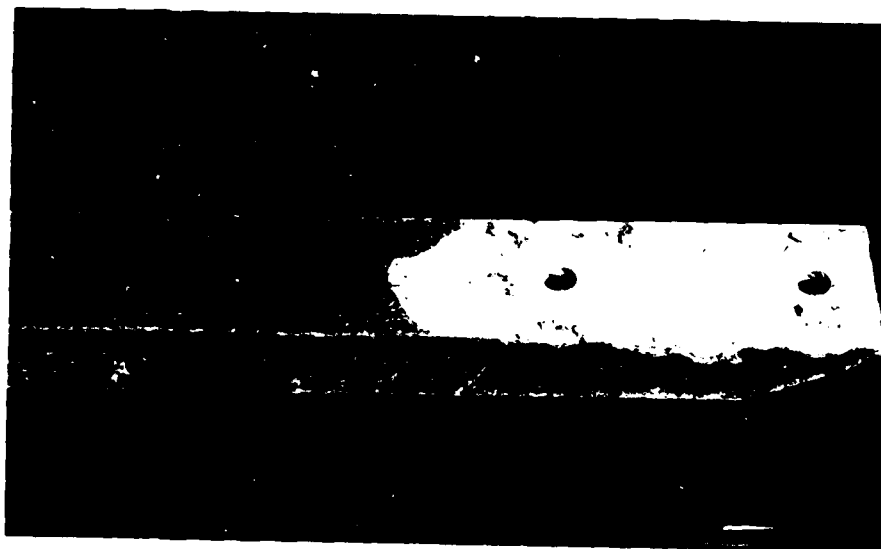
At all points on the structure where there were crevices, crevice corrosion was found. In most areas the attack was not severe. However, in other areas the attack was significant. The area most adversely affected by crevice corrosion was the point where the base ring braces were attached to the mast. Even though the crevices at this joint were sealed with room temperature vulcanizing silicone rubber compound some seawater entered the crevices. This resulted in attack such as shown in Figure 9. In this area the attack was up to .095" deep. Metallographic inspection of sections from this area showed that the channel sections at the base-ring-brace to mast joints had corroded transgranularly. The microstructure of the uncorroded material was typical of as extruded (H-111)

Figure 9. Crevice attack on base brace.

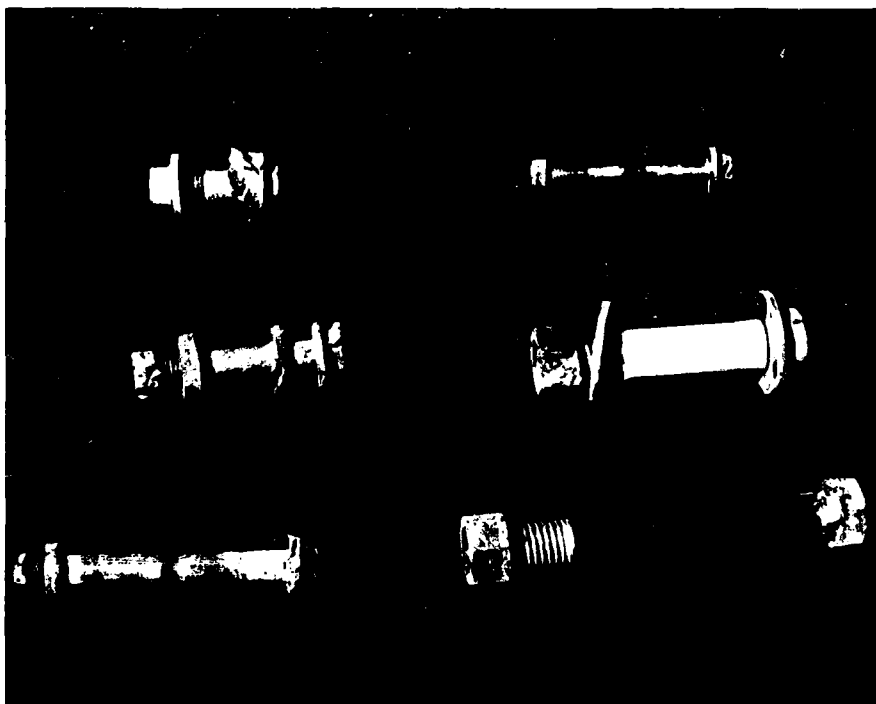
The Nickel-Copper alloy 400 fasteners used to assemble the structure, as shown in Figure 11, were not significantly attacked. The only attack noted other than a slight tarnish was slight crevice attack under the heads and on the threads of a few fasteners. This attack was structurally insignificant. The PVC base ring and couplings as well as the various non-metallic insulating sleeves and washers used on the structure were not significantly affected by their exposure at depth. Damage to the base ring was mechanical, and as evidenced by the lack of fouling on the damage-exposed surfaces, and probably occurred during recovery.

Figure 11. Fasteners and insulators.
